Asbestos Management Survey for Arches Housing Limited

140-142 Burngreave Road (communal areas)
Sheffield
South Yorkshire
S3 9DH

Project Number: 5055-01

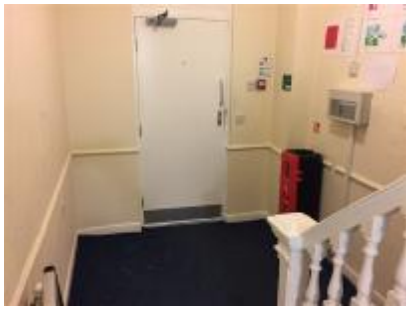
Area/ Floor/ Room/ Product: Main Building: Ground floor: Entrance lobby: General view

Material Comments:
General view. Plaster ceiling. Solid and plaster walls. Carpet onto hardboard to timber floor. Timber door and header. Timber skirting. No access was gained into the timber boxing.

Action:
No Action Required

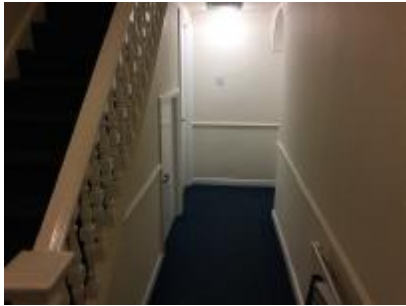
Area/ Floor/ Room/ Product: Main Building: Ground floor: Corridor: General view

Material Comments:
General view. Plasterboard ceiling. Solid and plaster walls. Carpet onto hardboard to timber floor. Timber doors. Timber skirting.

Action:
No Action Required

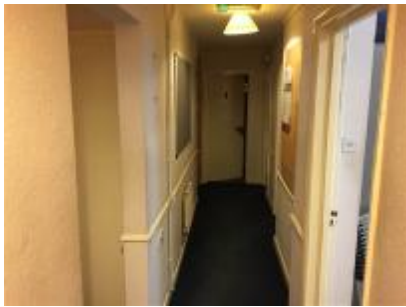
Area/ Floor/ Room/ Product: Main Building: Ground floor: Corridor: General view

Material Comments:
General view. Plasterboard ceiling. Solid and plasterboard walls. Carpet to concrete floor. Timber doors. Timber skirting. Unlagged pipework.

Action:
No Action Required

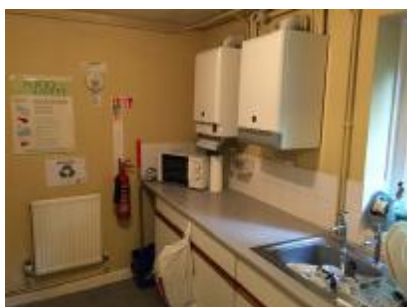
Location Ref: 005

Damage: NADIS

No Action Required

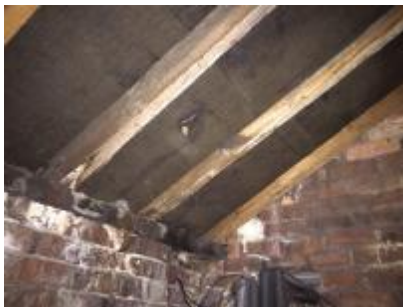
Location Ref: 007a

Damage: NADIS

No Action Required

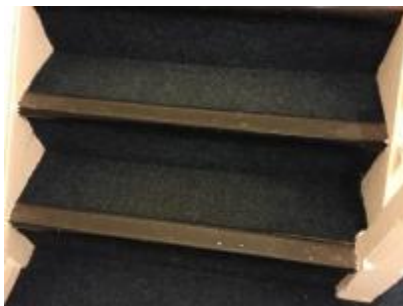
Location Ref: 010

Damage: NADIS

No Action Required

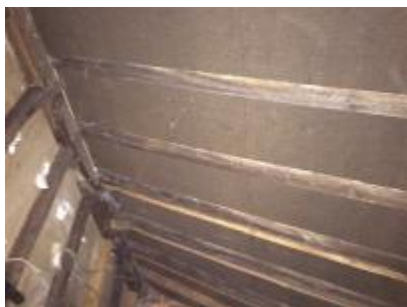
Area/ Floor/ Room/ Product: Main Building: Loft Space: Shower room: Felt

Material Comments:
Non asbestos bitumen felt lining the underside of the roof. Brick and plasterboard walls. Mmmf insulation. Foam lagged pipework. Non asbestos board 'Supalux' ceiling hatch.

Action:
No Action Required

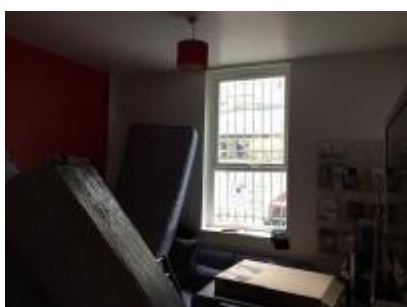
Area/ Floor/ Room/ Product: Main Building: Ground floor: Lounge: General view

Material Comments:
General view. Plasterboard ceiling. Solid and plasterboard walls. Carpet to concrete floor. Timber door. Timber skirting. Plastic window frame, timber sill. Unlagged pipework.

Action:
No Action Required

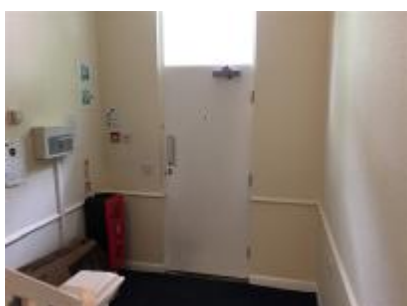
Area/ Floor/ Room/ Product: Main Building: Ground floor: Entrance lobby: General view

Material Comments:
General view. Plaster ceiling. Solid and plaster walls. Carpet onto hardboard to timber floor. Timber door, glazed header. Timber skirting.

Action:
No Action Required

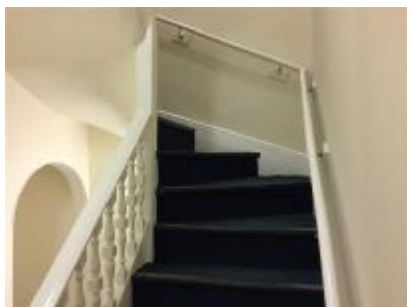
Area/ Floor/ Room/ Product: Main Building: First to second floor: Stairs & landing: General view

Material Comments:
General view. Plaster ceilings and stairs stair soffits. Solid and plaster walls. Carpet to timber floor and stairs. Timber doors. Timber skirting. Timber handrails.

Action:
No Action Required

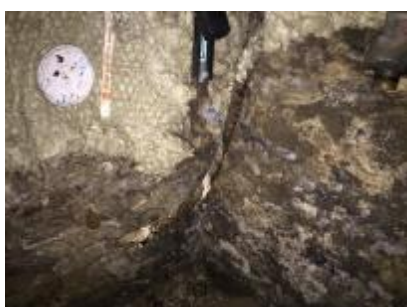
Area/ Floor/ Room/ Product: Main Building: Basement: Cellar: Bitumen

Material Comments:
Non asbestos bitumen cable wrap. Plasterboard ceiling and stairs soffit. Brick walls and floor. Brick and concrete stairs. Timber door. Foam lagged pipework. Mmmf insulation. The electrical units are mounted onto chipboard panels.

Action:
No Action Required

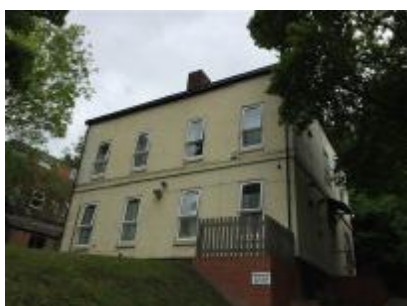
Area/ Floor/ Room/ Product: Main Building: Ground floor: External: General view

Material Comments:
General view. Presumed slate tiled main roof. Concrete tiles to the lower roof. Brick walls. Timber door. Plastic window frames. Plastic rainwater goods. Plastic soil pipe.

Action:
No Action Required
