Asbestos Management Survey for Arches Housing Limited

36-38 Burngreave Road (communal areas)
Sheffield
South Yorkshire
S3 9DD

Project Number: 5055-04

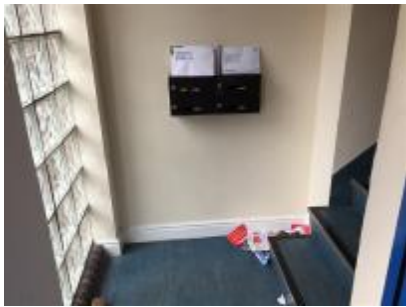
Area/ Floor/ Room/ Product: Main Building: Ground floor: Entrance lobby: General view

Material Comments:
General view. Plasterboard ceiling. Solid walls. Modern vinyl floor covering to concrete floor. Timber door. Timber skirting. Glazing wall blocks.

Action:
No Action Required

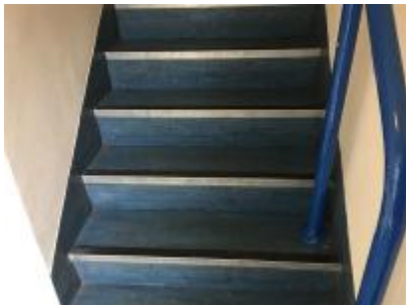
Area/ Floor/ Room/ Product: Main Building: Ground to first floor: Stairs: Stair nosing

Material Comments:
Non asbestos plastic stair nosing. Solid soffit and walls. Modern vinyl floor covering to concrete stairs. Modern vinyl skirting. Metal hand rail.

Action:
No Action Required

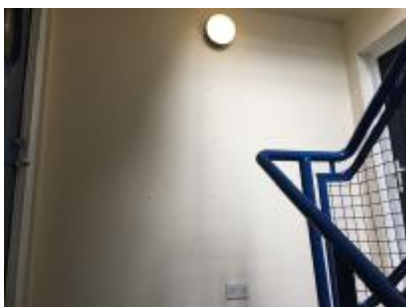
Area/ Floor/ Room/ Product: Main Building: First floor: Landing: Wall panels

Material Comments:
Non asbestos insulating board 'Supalux' wall panels. Solid ceiling. Modern vinyl floor covering to concrete floor. Timber and plastic doors. Timber skirting.

Action:
No Action Required

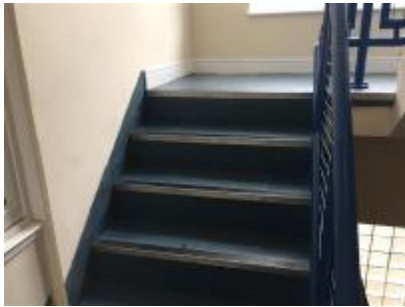
Area/ Floor/ Room/ Product: Main Building: First & second floor: Stairs: Stair nosing

Non asbestos plastic stair nosing. Solid walls. Modern vinyl floor covering to concrete stairs. Timber and modern vinyl skirting. Metal hand rail. Plastic window frame. Timber sill.

No Action Required

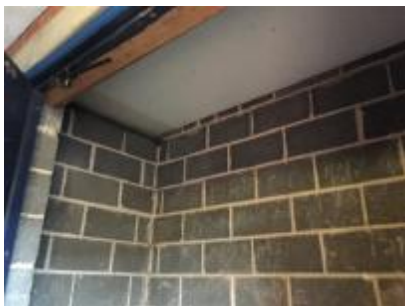
Location Ref: 011

06/06/17	011	39562	N/a	Ground floor	Bin store	NADIS	Boarding	0	NADIS	N/A	Non asbestos insulating board 'Supalux' soffit panels - as sample 009. Block walls. Concrete floor. Timber door.	No Action Required	MS
06/06/17	012	39563	N/a	Ground floor	Meter cupboard	Not Applicable	General view	0	Not Applicable	N/A	General view. Concrete block soffit. Brick walls. Concrete floor. Timber door. Unlagged pipework. The electrical units are mounted to chipboard panels.	No Action Required	MS
06/06/17	013	39564	N/a	Ground floor	Store cupboard	Not Applicable	General view	0	Not Applicable	N/A	General view. Concrete soffit. Block walls. Concrete floor. Timber door. Modern electrical distribution unit.	No Action Required	MS
06/06/17	014	39565	N/a	Ground floor	External	NADIS	Bitumen	0	NADIS	N/A	Non asbestos bitumen damp proof course to the brick walls.	No Action Required	MS

No Action Required
