ASBESTOS SURVEY REPORT

SURVEY TYPE : Re-inspection Survey

SURVEY REPORT NO. : ARH/UP/JD/08375

ADDRESS : Ashtree Court
Eccles Street
Sheffield
South Yorkshire
S9 1LR

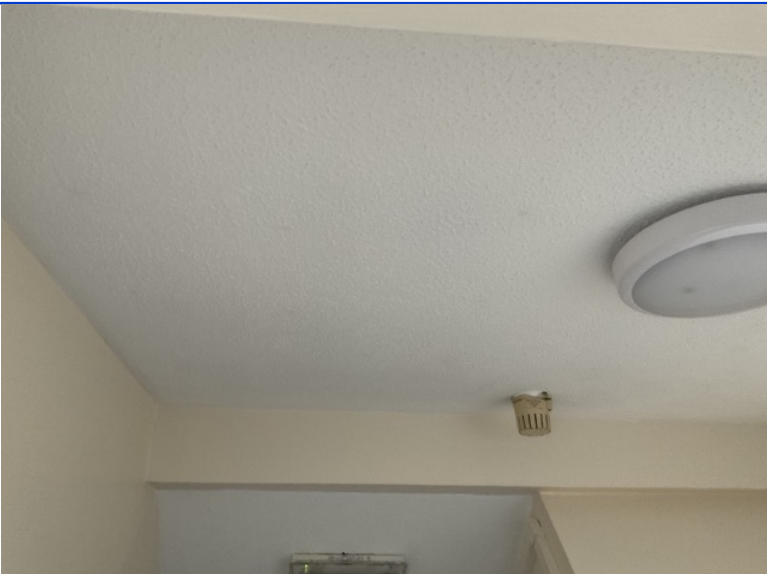
Site	Ashtree Court, Eccles Street, Sheffield, South Yorkshire, S9 1LR		
Building		Floor	2
Location	Landing		
Building Component	Coating to Ceiling		
Material	Textured Coating		
Area References	0001/05

Analysis Result	Chrysotile	
Quantity	6 m ²

Material Assessment Algorithm				Results				
Product Type	Damage	Surface Treatment	Asbestos Type	Material Score	Access	Total	Action Priority	Recommendation
1	0	0	1	2	2	4	Low	Manage

The material is known to contain Chrysotile as identified in the Management Asbestos Survey. Sample reference number RM/49960.

The material is in a good condition and no damage was identified.

Materials of this type are not likely to give rise to significant fibre release and may therefore be left in situ. The material should however be monitored periodically to assess its condition.

The removal or encapsulation of materials of this type do not require the use of a licensed asbestos removal contractor although they should be carried out in a controlled manner and materials disposed of as asbestos waste in accordance with the 'Control of Asbestos Regulations 2012'.

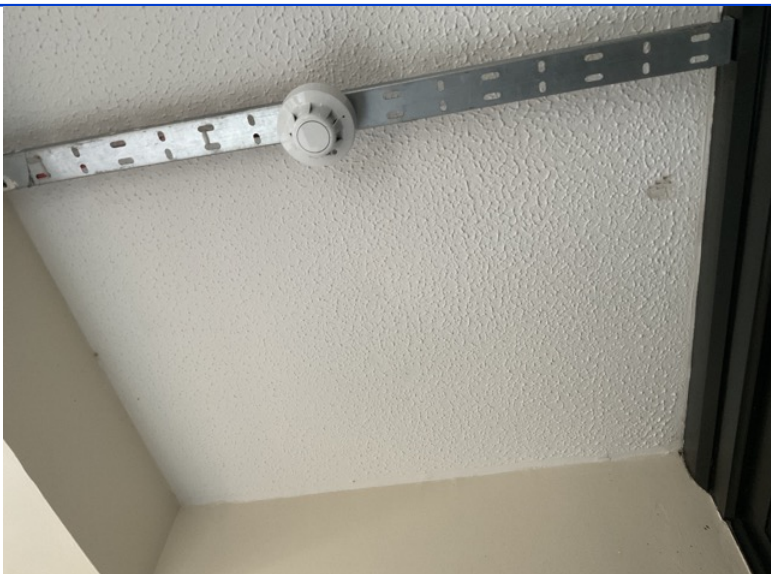
Site	Ashtree Court, Eccles Street, Sheffield, South Yorkshire, S9 1LR		
Building		Floor	G
Location	Entrance		
Building Component	Coating to Ceiling		
Material	Textured Coating		
Area References	0003/05

Analysis Result	Chrysotile	
Quantity	2 m ²

Material Assessment Algorithm				Results				
Product Type	Damage	Surface Treatment	Asbestos Type	Material Score	Access	Total	Action Priority	Recommendation
1	0	0	1	2	1	2	Low	Manage

The material is known to contain Chrysotile as identified in the Management Asbestos Survey. Sample reference number RM/49961.

The material is in a good condition and no damage was identified.

Materials of this type are not likely to give rise to significant fibre release and may therefore be left in situ. The material should however be monitored periodically to assess its condition.

The removal or encapsulation of materials of this type do not require the use of a licensed asbestos removal contractor although they should be carried out in a controlled manner and materials disposed of as asbestos waste in accordance with the 'Control of Asbestos Regulations 2012'.

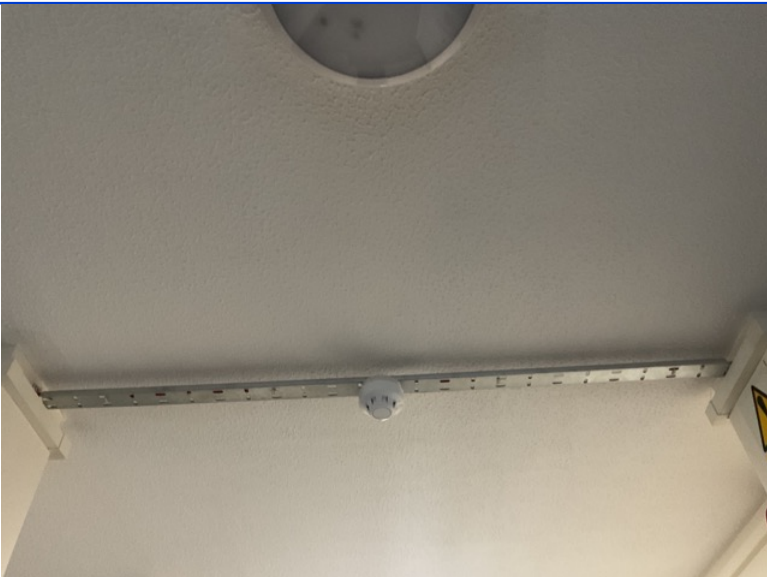
Site	Ashtree Court, Eccles Street, Sheffield, South Yorkshire, S9 1LR		
Building		Floor	G
Location	Hall		
Building Component	Coating to Ceiling		
Material	Textured Coating		
Area References	0004/06

Analysis Result	Chrysotile	
Quantity	16 m ²

Material Assessment Algorithm				Results				
Product Type	Damage	Surface Treatment	Asbestos Type	Material Score	Access	Total	Action Priority	Recommendation
1	0	0	1	2	1	2	Low	Manage

The material is known to contain Chrysotile as identified in the Management Asbestos Survey. Sample reference number RM/49961.

The material is in a good condition and no damage was identified.

Materials of this type are not likely to give rise to significant fibre release and may therefore be left in situ. The material should however be monitored periodically to assess its condition.

The removal or encapsulation of materials of this type do not require the use of a licensed asbestos removal contractor although they should be carried out in a controlled manner and materials disposed of as asbestos waste in accordance with the 'Control of Asbestos Regulations 2012'.

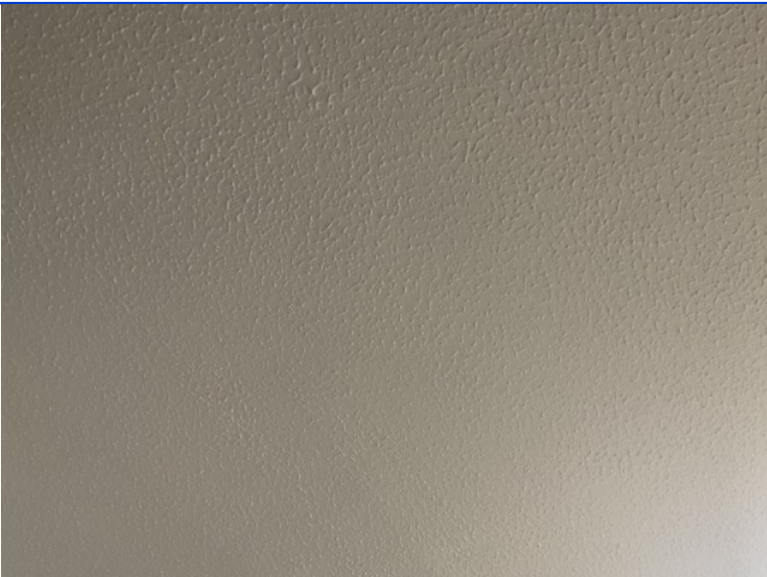
Site	Ashtree Court, Eccles Street, Sheffield, South Yorkshire, S9 1LR		
Building		Floor	G
Location	Bedroom		
Building Component	Coating to Ceiling		
Material	Textured Coating		
Area References	0006/07

Analysis Result	Chrysotile	
Quantity	16 m ²

Material Assessment Algorithm				Results				
Product Type	Damage	Surface Treatment	Asbestos Type	Material Score	Access	Total	Action Priority	Recommendation
1	0	0	1	2	1	2	Low	Manage

The material is known to contain Chrysotile as identified in the Management Asbestos Survey. Sample reference number RM/49962.

The material is in a good condition and no damage was identified.

Materials of this type are not likely to give rise to significant fibre release and may therefore be left in situ. The material should however be monitored periodically to assess its condition.

The removal or encapsulation of materials of this type do not require the use of a licensed asbestos removal contractor although they should be carried out in a controlled manner and materials disposed of as asbestos waste in accordance with the 'Control of Asbestos Regulations 2012'.

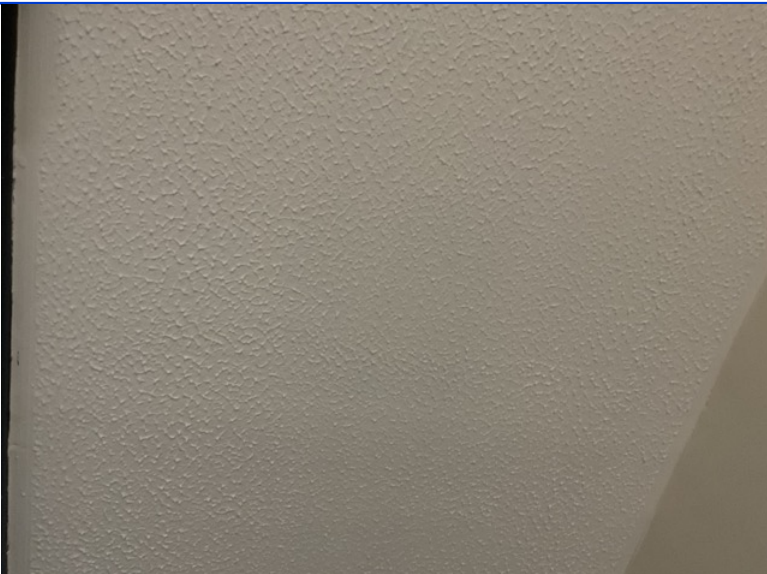
Site	Ashtree Court, Eccles Street, Sheffield, South Yorkshire, S9 1LR		
Building		Floor	G
Location	Cupboard Under Stairs		
Building Component	Coating to Ceiling		
Material	Textured Coating		
Area References	0007/05

Analysis Result	Chrysotile	
Quantity	2 m ²

Material Assessment Algorithm				Results				
Product Type	Damage	Surface Treatment	Asbestos Type	Material Score	Access	Total	Action Priority	Recommendation
1	0	0	1	2	3	6	Low	Manage

The material is known to contain Chrysotile as identified in the Management Asbestos Survey. Sample reference number RM/49961.

The material is in a good condition and no damage was identified.

Materials of this type are not likely to give rise to significant fibre release and may therefore be left in situ. The material should however be monitored periodically to assess its condition.

The removal or encapsulation of materials of this type do not require the use of a licensed asbestos removal contractor although they should be carried out in a controlled manner and materials disposed of as asbestos waste in accordance with the 'Control of Asbestos Regulations 2012'.

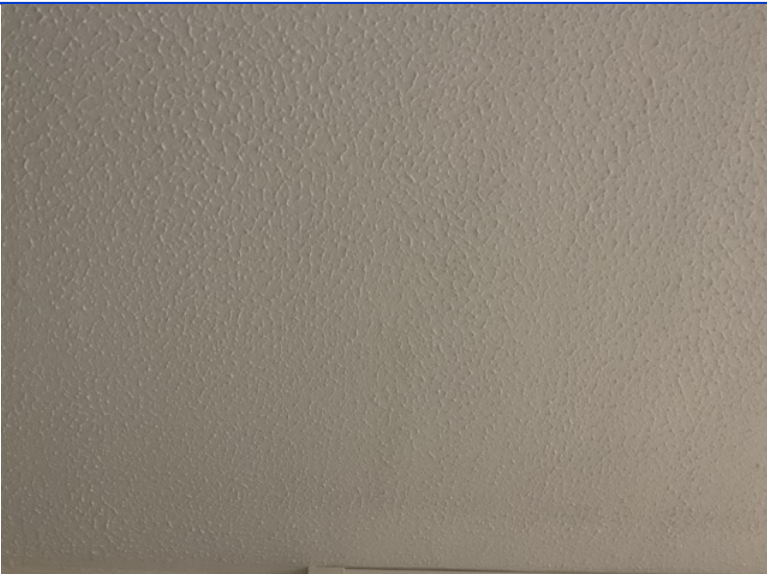
Site	Ashtree Court, Eccles Street, Sheffield, South Yorkshire, S9 1LR		
Building		Floor	G
Location	W.C.		
Building Component	Coating to Ceiling		
Material	Textured Coating		
Area References	0008/07

Analysis Result	Chrysotile	
Quantity	3 m ²

Material Assessment Algorithm				Results				
Product Type	Damage	Surface Treatment	Asbestos Type	Material Score	Access	Total	Action Priority	Recommendation
1	0	0	1	2	1	2	Low	Manage

The material is known to contain Chrysotile as identified in the Management Asbestos Survey. Sample reference number RM/49963.

The material is in a good condition and no damage was identified.

Materials of this type are not likely to give rise to significant fibre release and may therefore be left in situ. The material should however be monitored periodically to assess its condition.

The removal or encapsulation of materials of this type do not require the use of a licensed asbestos removal contractor although they should be carried out in a controlled manner and materials disposed of as asbestos waste in accordance with the 'Control of Asbestos Regulations 2012'.

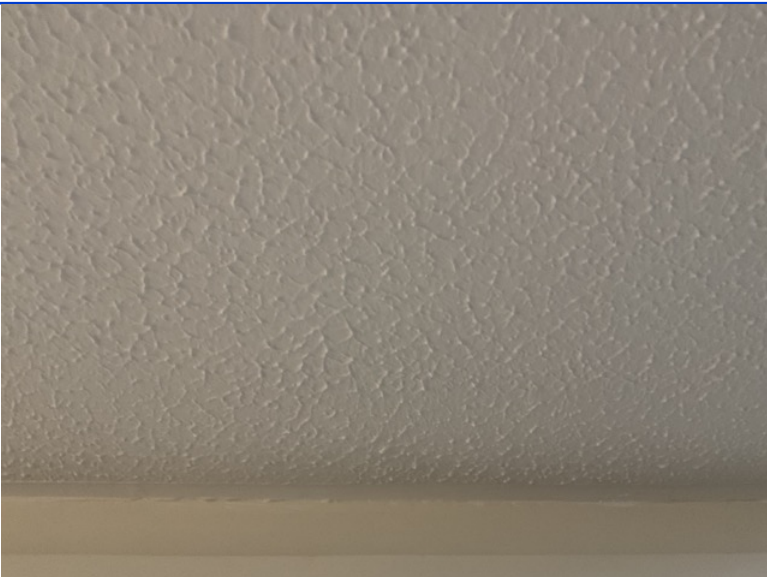
Site	Ashtree Court, Eccles Street, Sheffield, South Yorkshire, S9 1LR		
Building		Floor	G
Location	Boiler Cupboard		
Building Component	Coating to Ceiling		
Material	Textured Coating		
Area References	0009/05

Analysis Result	Chrysotile	
Quantity	1 m ²

Material Assessment Algorithm				Results				
Product Type	Damage	Surface Treatment	Asbestos Type	Material Score	Access	Total	Action Priority	Recommendation
1	0	0	1	2	1	2	Low	Manage

The material is known to contain Chrysotile as identified in the Management Asbestos Survey. Sample reference number RM/49963.

The material is in a good condition and no damage was identified.

Materials of this type are not likely to give rise to significant fibre release and may therefore be left in situ. The material should however be monitored periodically to assess its condition.

The removal or encapsulation of materials of this type do not require the use of a licensed asbestos removal contractor although they should be carried out in a controlled manner and materials disposed of as asbestos waste in accordance with the 'Control of Asbestos Regulations 2012'.
