## REINSPECTION ASBESTOS SURVEY

ASH TREE COURT  
ECCLES STREET  
SHEFFIELD  
SOUTH YORKSHIRE  
S9 1LR

**NES /JC02/2856**

TYPE OF SURVEY	DATE OF SURVEY	REPORT STATUS
Reinspection	14th January 2026	Final

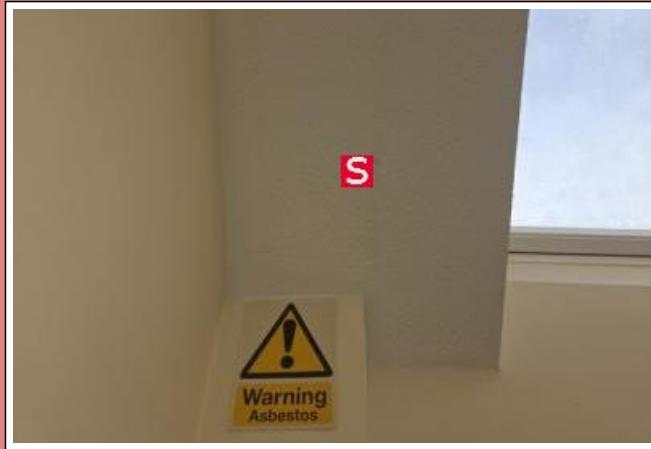
SAMPLE NUMBER	NES /JC02/2856/1	QUANTITY	6 m <sup>2</sup>	SCORE
CLIENT	Arches Housing	MATERIAL/PRODUCT	Text Coating	1
SURVEY LOCATION	Ash Tree Court	DAMAGE	Good Condition	0
FLOOR	Communal Second Floor	SURFACE TREATMENT	Unsealed 1	2
LOCATION	Landing	ASBESTOS TYPE	Chrysotile (White)	1
TYPE OF SURVEY	Reinspection		RISK SCORE TOTAL	4
DATE OF SURVEY	14th Jan 2026	IDENTIFICATION LEVEL	Inspected	
SURVEYOR	Jamie Cain	ACCESSIBILITY	Low	
NEXT INSPECTION	14th Jan 2027	MATERIAL HAZARD RATING	V.LOW	PRIORITY 3 Manage

The text coating that was identified by BDA Surveying LTD ref 0001/05 was re-inspected on the 14/01/2025 and there is no deterioration in the material.

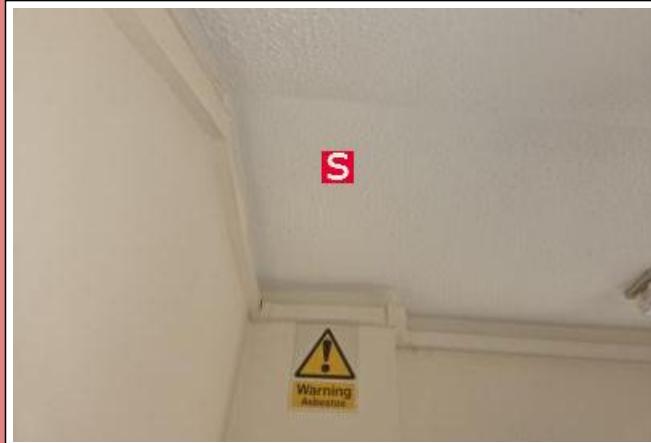
SAMPLE NUMBER	NES /JC02/2856/2	QUANTITY	8 m <sup>2</sup>	SCORE
CLIENT	Arches Housing	MATERIAL/PRODUCT	Text Coating	1
SURVEY LOCATION	Ash Tree Court	DAMAGE	Good Condition	0
FLOOR	Communal First Floor	SURFACE TREATMENT	Unsealed 1	2
LOCATION	Landing	ASBESTOS TYPE	Chrysotile (White)	1
TYPE OF SURVEY	Reinspection		RISK SCORE TOTAL	4
DATE OF SURVEY	14th Jan 2026	IDENTIFICATION LEVEL	Inspected	
SURVEYOR	Jamie Cain	ACCESSIBILITY	Low	
NEXT INSPECTION	14th Jan 2027	MATERIAL HAZARD RATING	V.LOW	PRIORITY 3 Manage

The text coating that was identified by BDA Surveying LTD ref 0002/05 was re-inspected on the 14/01/2025 and there is no deterioration in the material.

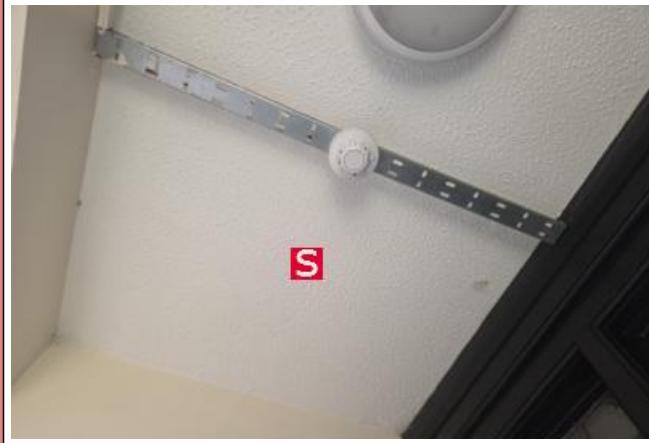
SAMPLE NUMBER	NES /JC02/2856/3	QUANTITY	2 m <sup>2</sup>	SCORE
CLIENT	Arches Housing	MATERIAL/PRODUCT	Text Coating	1
SURVEY LOCATION	Ash Tree Court	DAMAGE	Good Condition	0
FLOOR	Communal Ground Floor	SURFACE TREATMENT	Unsealed 1	2
LOCATION	Entrance	ASBESTOS TYPE	Chrysotile (White)	1
TYPE OF SURVEY	Reinspection		RISK SCORE TOTAL	4
DATE OF SURVEY	14th Jan 2026	IDENTIFICATION LEVEL	Inspected	
SURVEYOR	Jamie Cain	ACCESSIBILITY	Low	
NEXT INSPECTION	14th Jan 2027	MATERIAL HAZARD RATING	V.LOW	PRIORITY 3 Manage

The text coating that was identified by BDA Surveying LTD ref 0003/05 was re-inspected on the 14/01/2025 and there is no deterioration in the material.

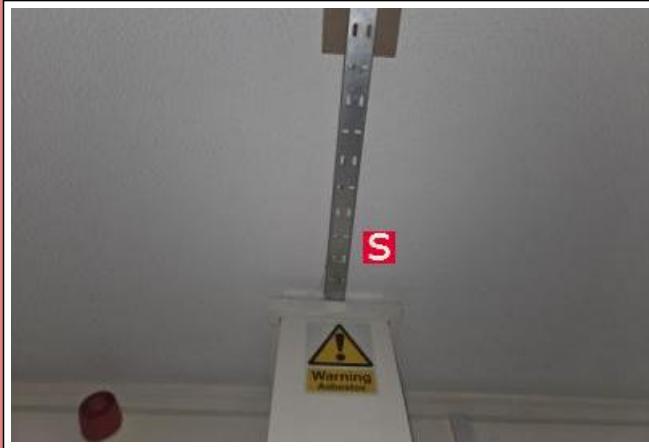
SAMPLE NUMBER	NES /JC02/2856/4	QUANTITY	16 m2	SCORE
CLIENT	Arches Housing	MATERIAL/PRODUCT	Text Coating	1
SURVEY LOCATION	Ash Tree Court	DAMAGE	Good Condition	0
FLOOR	Communal Ground Floor	SURFACE TREATMENT	Unsealed 1	2
LOCATION	Hall	ASBESTOS TYPE	Chrysotile (White)	1
TYPE OF SURVEY	Reinspection		RISK SCORE TOTAL	4
DATE OF SURVEY	14th Jan 2026	IDENTIFICATION LEVEL	Inspected	
SURVEYOR	Jamie Cain	ACCESSIBILITY	Low	
NEXT INSPECTION	14th Jan 2027	MATERIAL HAZARD RATING	V.LOW	PRIORITY 3 Manage

The text coating that was identified by BDA Surveying LTD ref 0004/05 was re-inspected on the 14/01/2025 and there is no deterioration in the material.

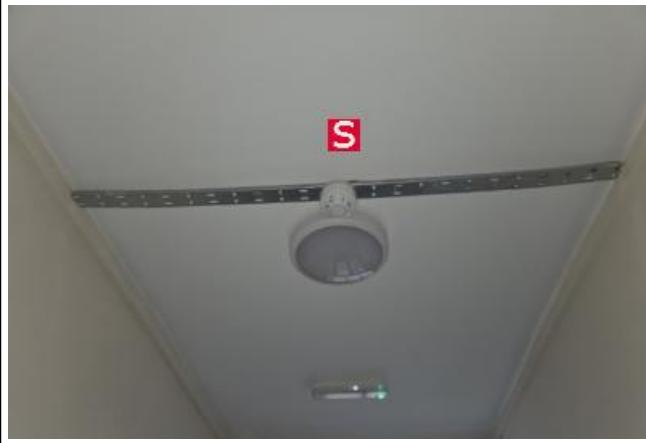
SAMPLE NUMBER	NES /JC02/2856/5	QUANTITY	5 m <sup>2</sup>	SCORE
CLIENT	Arches Housing	MATERIAL/PRODUCT	Text Coating	1
SURVEY LOCATION	Ash Tree Court	DAMAGE	Good Condition	0
FLOOR	Communal Ground Floor	SURFACE TREATMENT	Unsealed 1	2
LOCATION	Lobby	ASBESTOS TYPE	Chrysotile (White)	1
TYPE OF SURVEY	Reinspection		RISK SCORE TOTAL	4
DATE OF SURVEY	14th Jan 2026	IDENTIFICATION LEVEL	Inspected	
SURVEYOR	Jamie Cain	ACCESSIBILITY	Low	
NEXT INSPECTION	14th Jan 2027	MATERIAL HAZARD RATING	V.LOW	PRIORITY 3 Manage

The text coating that has was identified by BDA Surveying LTD ref 0005/05 was re-inspected on the 14/01/2025 and there is no deterioration in the material.

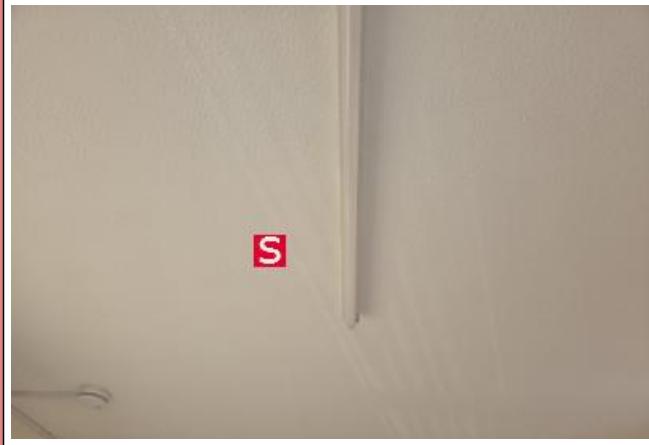
SAMPLE NUMBER	NES /JC02/2856/6	QUANTITY	16 m2	SCORE
CLIENT	Arches Housing	MATERIAL/PRODUCT	Text Coating	1
SURVEY LOCATION	Ash Tree Court	DAMAGE	Good Condition	0
FLOOR	Communal Ground Floor	SURFACE TREATMENT	Unsealed 1	2
LOCATION	Former Bedroom-Now Office	ASBESTOS TYPE	Chrysotile (White)	1
TYPE OF SURVEY	Reinspection		RISK SCORE TOTAL	4
DATE OF SURVEY	14th Jan 2026	IDENTIFICATION LEVEL	Inspected	
SURVEYOR	Jamie Cain	ACCESSIBILITY	Low	
NEXT INSPECTION	14th Jan 2027	MATERIAL HAZARD RATING	V.LOW	PRIORITY 3 Manage

The text coating that was identified by BDA Surveying LTD ref 0006/07 was re-inspected on the 14/01/2025 and there is no deterioration in the material.

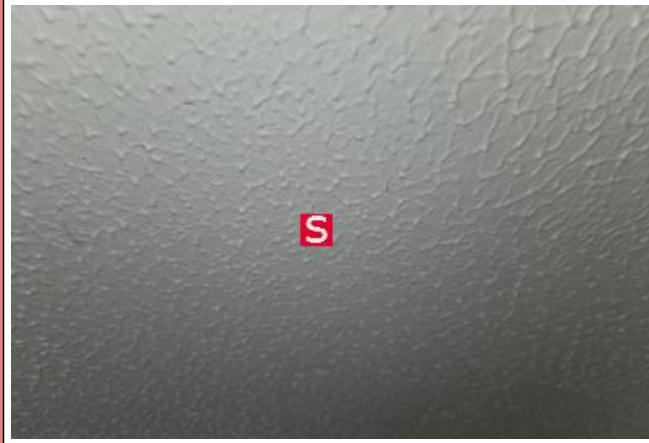
SAMPLE NUMBER	NES /JC02/2856/7	QUANTITY	2 m <sup>2</sup>	SCORE
CLIENT	Arches Housing	MATERIAL/PRODUCT	Text Coating	1
SURVEY LOCATION	Ash Tree Court	DAMAGE	Good Condition	0
FLOOR	Communal Ground Floor	SURFACE TREATMENT	Unsealed 1	2
LOCATION	Under Stair Cupboard	ASBESTOS TYPE	Chrysotile (White)	1
TYPE OF SURVEY	Reinspection		RISK SCORE TOTAL	4
DATE OF SURVEY	14th Jan 2026	IDENTIFICATION LEVEL	Inspected	
SURVEYOR	Jamie Cain	ACCESSIBILITY	Low	
NEXT INSPECTION	14th Jan 2027	MATERIAL HAZARD RATING	V.LOW	PRIORITY 3 Manage

The text coating that was identified by BDA Surveying LTD ref 0007/05 was re-inspected on the 14/01/2025 and there is no deterioration in the material.

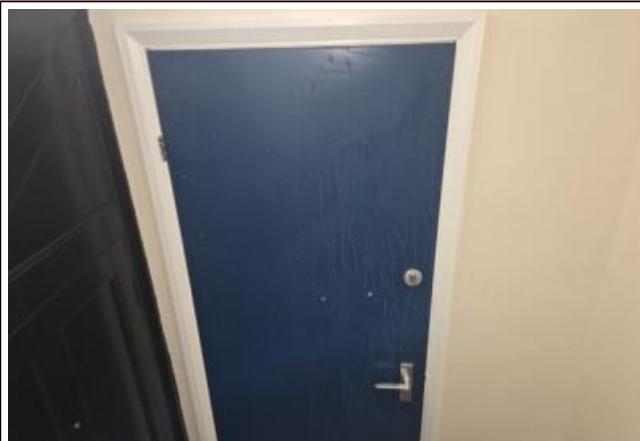
SAMPLE NUMBER	NES /JC02/2856/8	QUANTITY	Estimated 4 m2	SCORE
CLIENT	Arches Housing	MATERIAL/PRODUCT	Text Coating	1
SURVEY LOCATION	Ash Tree Court	DAMAGE	Good Condition	0
FLOOR	Communal Ground Floor	SURFACE TREATMENT	Unsealed 1	2
LOCATION	Wc & Small Boiler Room	ASBESTOS TYPE	Chrysotile (White)	1
TYPE OF SURVEY	Reinspection		RISK SCORE TOTAL	4
DATE OF SURVEY	14th Jan 2026	IDENTIFICATION LEVEL	Inspected	
SURVEYOR	Jamie Cain	ACCESSIBILITY	Low	
NEXT INSPECTION	14th Jan 2027	MATERIAL HAZARD RATING	V.LOW	PRIORITY 3 Manage

This room was not inspected as no keys were kept on site.
