FIRE RISK ASSESSMENT

Burngreave Road 140-142

**140-142 Burngreave Road,
Pitsmoor, Sheffield,
South Yorkshire, S3 9DH**

ASSESSED BY	Luke Colwell FSIDip, DipFD MIFSM, Tier 2 CFRAR
ASSESSED ON	25/03/2025
FIRE QC BY	Christopher Cotterill BSc (Hons) MIFSM TechIOSH NAFRAR Tier 3
FIRE QC ON	01/04/2025
PROPERTY REF.	RB-38GEUU
ASSESSMENT REF.	438209
VERSION	1

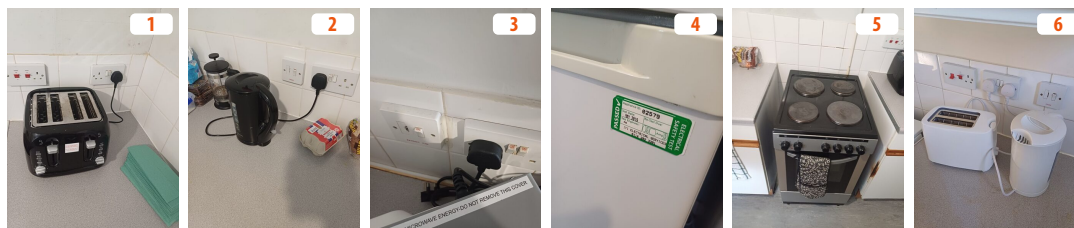
No evidence that landlord provided items (white goods and cooking appliances) have been PAT tested.

Ensure all relevant items are PAT tested.

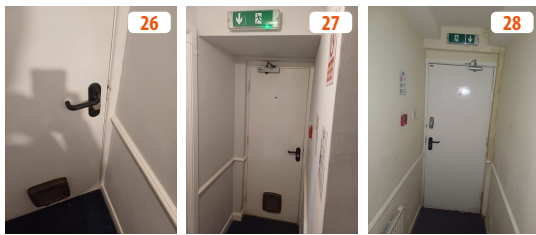
The cross corridor door between the main corridor and fire escape (near to the laundry room) has both a standard lock and a keypad lock fitted. This means that not only are there two methods of opening the door, but also occupants may not be able to walk through from the laundry room side, limiting the number of escape routes on that side of the building. It is recommended that the keypad lock be removed and the door professionally repaired by a qualified contractor.

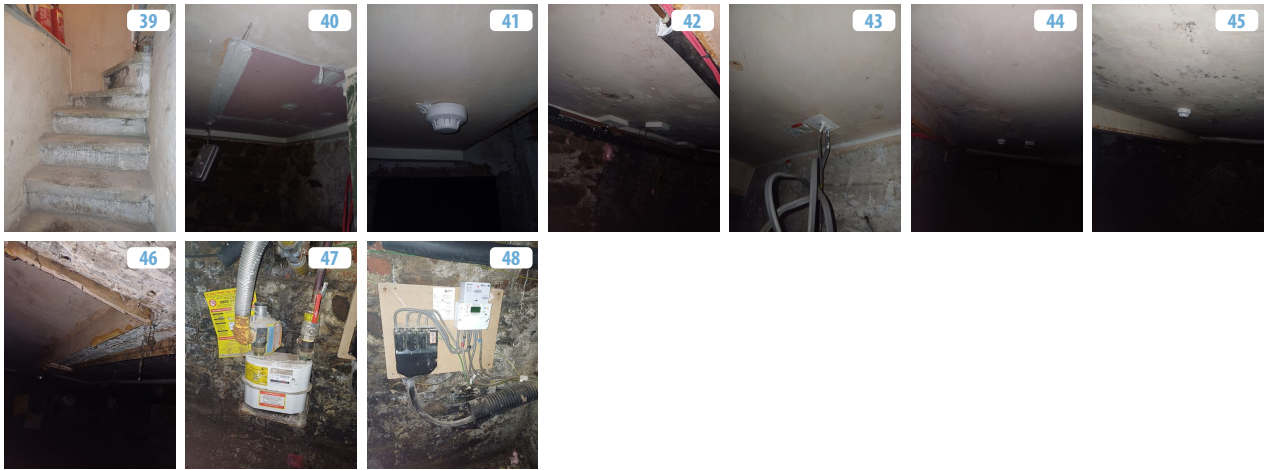
Electrical fuse boards were noted within the means of escape. However, they are of metal construction and, provided they are kept shut, should not pose a significant risk.
To reduce the risk from ignition sources along the means of escape.

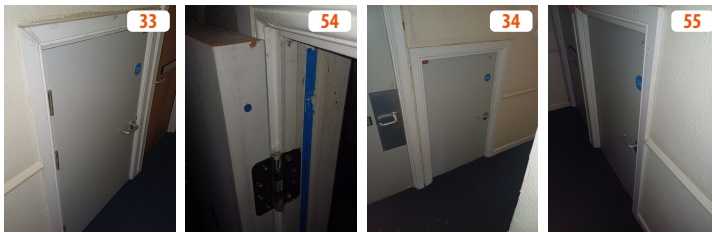
The flat 4 entrance door was sampled and had excessive door jamb gaps. Adjust the hinges to reduce these to between 2mm and 4mm.

It is recommended that all flat entrance doors are checked for suitability.

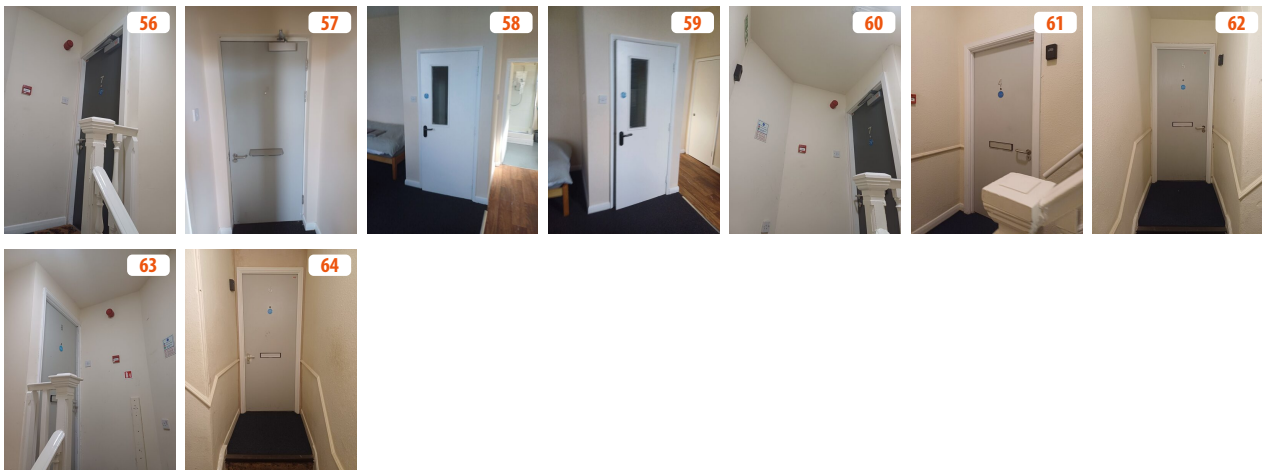
The door to the staff office has an excessive top gap. Adjust the hinges to ensure that the top gap is between 2mm and 4mm. If, in doing so, the threshold gap becomes greater than 10mm, fit a drop seal to lessen the gap.

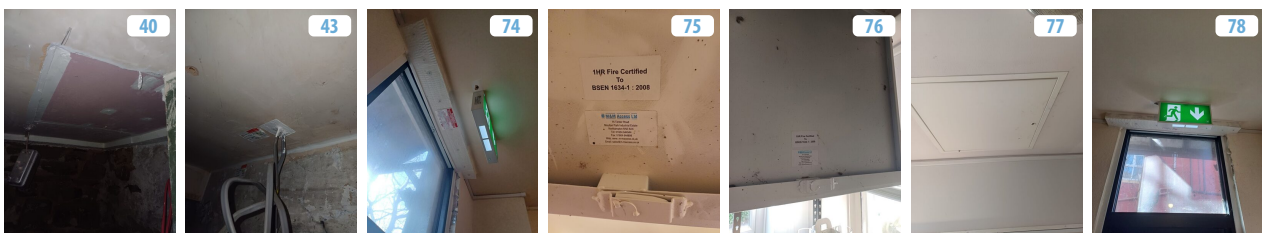
The two roof void access hatches on the first floor were accessed. The block work continues to the underside of the roof with no breaches noted. There is a fire curtain fitted above a store, but it doesn't seem to be in line with a compartment wall below and may not be required.

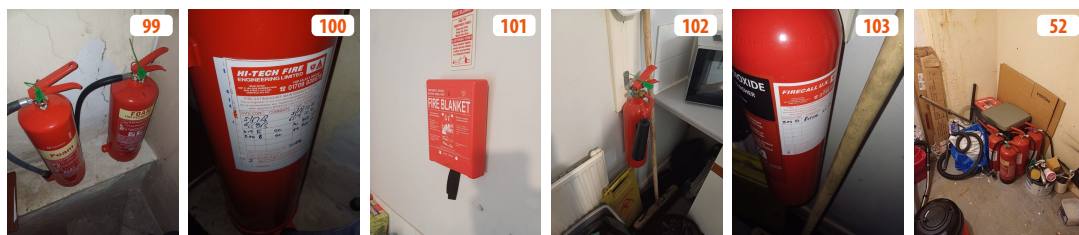
There was no fire blanket fitted in the kitchen of flat 4. Recommend fitting a fire blanket and training the resident on its use.

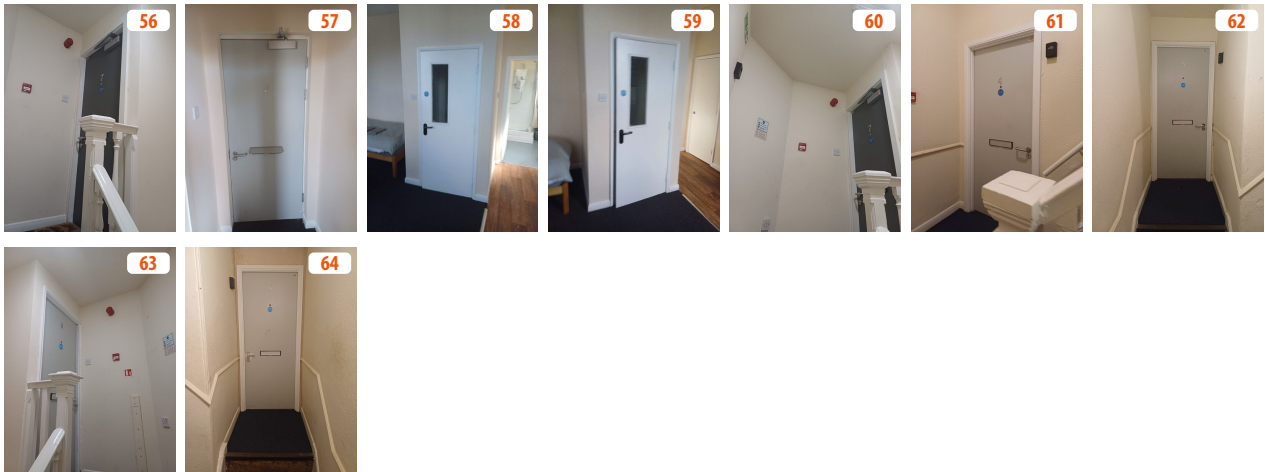
The two basement entrance doors have no cold smoke seals fitted. Fit cold smoke seals to the doors.
