## REINSPECTION ASBESTOS SURVEY

ASH TREE COURT  
ECCLES STREET  
SHEFFIELD  
SOUTH YORKSHIRE  
S9 1LR

**NES /JC02/2856**

TYPE OF SURVEY	DATE OF SURVEY	REPORT STATUS
Reinspection	14th January 2026	Final

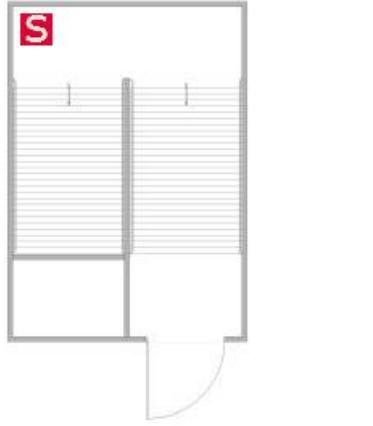
## FLOOR PLAN

SAMPLE NUMBER	NES /JC02/2856/1	QUANTITY	6 m <sup>2</sup>	SCORE
CLIENT	Arches Housing	MATERIAL/PRODUCT	Text Coating	1
SURVEY LOCATION	Ash Tree Court	DAMAGE	Good Condition	0
FLOOR	Communal Second Floor	SURFACE TREATMENT	Unsealed 1	2
LOCATION	Landing	ASBESTOS TYPE	Chrysotile (White)	1
TYPE OF SURVEY	Reinspection		RISK SCORE TOTAL	4
DATE OF SURVEY	14th Jan 2026	IDENTIFICATION LEVEL	Inspected	
SURVEYOR	Jamie Cain	ACCESSIBILITY	Low	
NEXT INSPECTION	14th Jan 2027	MATERIAL HAZARD RATING	V.LOW	PRIORITY 3 Manage

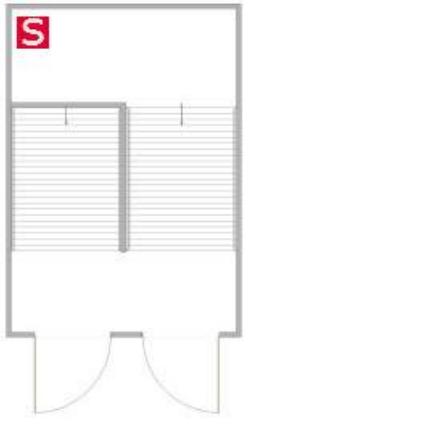
## FLOOR PLAN

SAMPLE NUMBER	NES /JC02/2856/2	QUANTITY	8 m <sup>2</sup>	SCORE
CLIENT	Arches Housing	MATERIAL/PRODUCT	Text Coating	1
SURVEY LOCATION	Ash Tree Court	DAMAGE	Good Condition	0
FLOOR	Communal First Floor	SURFACE TREATMENT	Unsealed 1	2
LOCATION	Landing	ASBESTOS TYPE	Chrysotile (White)	1
TYPE OF SURVEY	Reinspection		RISK SCORE TOTAL	4
DATE OF SURVEY	14th Jan 2026	IDENTIFICATION LEVEL	Inspected	
SURVEYOR	Jamie Cain	ACCESSIBILITY	Low	
NEXT INSPECTION	14th Jan 2027	MATERIAL HAZARD RATING	V.LOW	PRIORITY 3 Manage

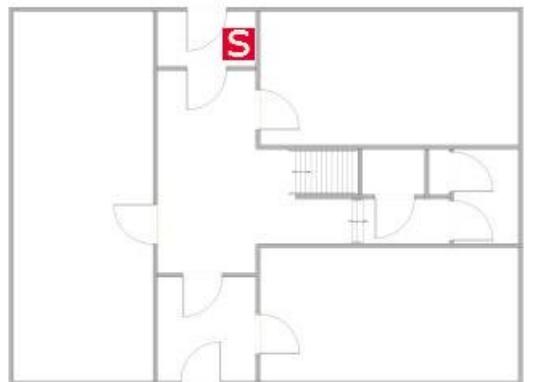
## FLOOR PLAN

SAMPLE NUMBER	NES /JC02/2856/3	QUANTITY	2 m <sup>2</sup>	SCORE
CLIENT	Arches Housing	MATERIAL/PRODUCT	Text Coating	1
SURVEY LOCATION	Ash Tree Court	DAMAGE	Good Condition	0
FLOOR	Communal Ground Floor	SURFACE TREATMENT	Unsealed 1	2
LOCATION	Entrance	ASBESTOS TYPE	Chrysotile (White)	1
TYPE OF SURVEY	Reinspection		RISK SCORE TOTAL	4
DATE OF SURVEY	14th Jan 2026	IDENTIFICATION LEVEL	Inspected	
SURVEYOR	Jamie Cain	ACCESSIBILITY	Low	
NEXT INSPECTION	14th Jan 2027	MATERIAL HAZARD RATING	V.LOW	PRIORITY 3 Manage

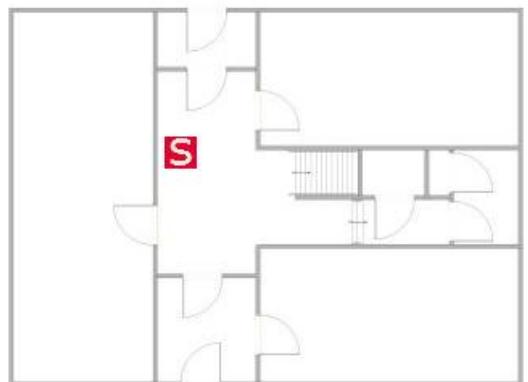
## FLOOR PLAN

SAMPLE NUMBER	NES /JC02/2856/4	QUANTITY	16 m2	SCORE
CLIENT	Arches Housing	MATERIAL/PRODUCT	Text Coating	1
SURVEY LOCATION	Ash Tree Court	DAMAGE	Good Condition	0
FLOOR	Communal Ground Floor	SURFACE TREATMENT	Unsealed 1	2
LOCATION	Hall	ASBESTOS TYPE	Chrysotile (White)	1
TYPE OF SURVEY	Reinspection		RISK SCORE TOTAL	4
DATE OF SURVEY	14th Jan 2026	IDENTIFICATION LEVEL	Inspected	
SURVEYOR	Jamie Cain	ACCESSIBILITY	Low	
NEXT INSPECTION	14th Jan 2027	MATERIAL HAZARD RATING	V.LOW	PRIORITY 3 Manage

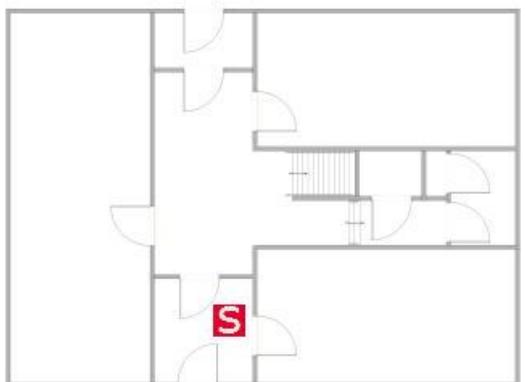
## FLOOR PLAN

SAMPLE NUMBER	NES /JC02/2856/5	QUANTITY	5 m <sup>2</sup>	SCORE
CLIENT	Arches Housing	MATERIAL/PRODUCT	Text Coating	1
SURVEY LOCATION	Ash Tree Court	DAMAGE	Good Condition	0
FLOOR	Communal Ground Floor	SURFACE TREATMENT	Unsealed 1	2
LOCATION	Lobby	ASBESTOS TYPE	Chrysotile (White)	1
TYPE OF SURVEY	Reinspection		RISK SCORE TOTAL	4
DATE OF SURVEY	14th Jan 2026	IDENTIFICATION LEVEL	Inspected	
SURVEYOR	Jamie Cain	ACCESSIBILITY	Low	
NEXT INSPECTION	14th Jan 2027	MATERIAL HAZARD RATING	V.LOW	PRIORITY 3 Manage

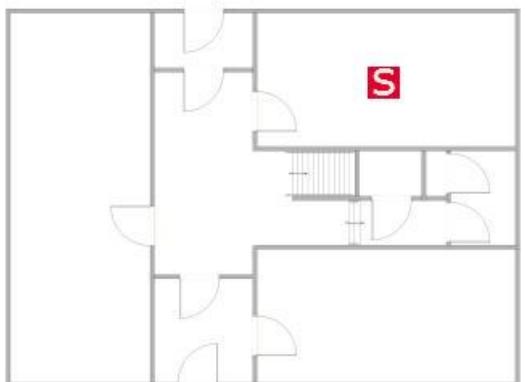
## FLOOR PLAN

SAMPLE NUMBER	NES /JC02/2856/6	QUANTITY	16 m2	SCORE
CLIENT	Arches Housing	MATERIAL/PRODUCT	Text Coating	1
SURVEY LOCATION	Ash Tree Court	DAMAGE	Good Condition	0
FLOOR	Communal Ground Floor	SURFACE TREATMENT	Unsealed 1	2
LOCATION	Former Bedroom-Now Office	ASBESTOS TYPE	Chrysotile (White)	1
TYPE OF SURVEY	Reinspection		RISK SCORE TOTAL	4
DATE OF SURVEY	14th Jan 2026	IDENTIFICATION LEVEL	Inspected	
SURVEYOR	Jamie Cain	ACCESSIBILITY	Low	
NEXT INSPECTION	14th Jan 2027	MATERIAL HAZARD RATING	V.LOW	PRIORITY 3 Manage

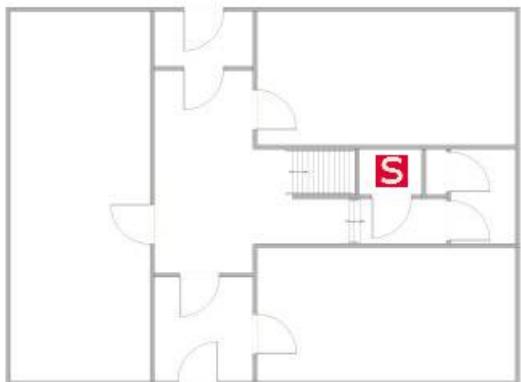
## FLOOR PLAN

SAMPLE NUMBER	NES /JC02/2856/7	QUANTITY	2 m <sup>2</sup>	SCORE
CLIENT	Arches Housing	MATERIAL/PRODUCT	Text Coating	1
SURVEY LOCATION	Ash Tree Court	DAMAGE	Good Condition	0
FLOOR	Communal Ground Floor	SURFACE TREATMENT	Unsealed 1	2
LOCATION	Under Stair Cupboard	ASBESTOS TYPE	Chrysotile (White)	1
TYPE OF SURVEY	Reinspection		RISK SCORE TOTAL	4
DATE OF SURVEY	14th Jan 2026	IDENTIFICATION LEVEL	Inspected	
SURVEYOR	Jamie Cain	ACCESSIBILITY	Low	
NEXT INSPECTION	14th Jan 2027	MATERIAL HAZARD RATING	V.LOW	PRIORITY 3 Manage

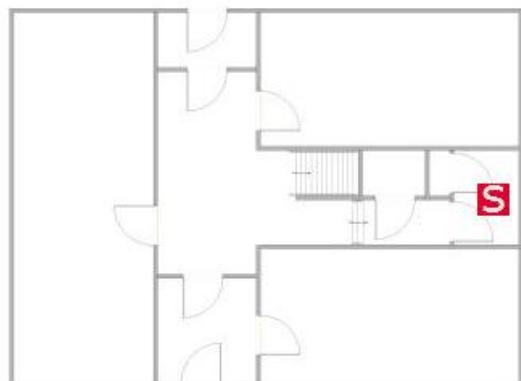
## FLOOR PLAN

SAMPLE NUMBER	NES /JC02/2856/8	QUANTITY	Estimated 4 m2	SCORE
CLIENT	Arches Housing	MATERIAL/PRODUCT	Text Coating	1
SURVEY LOCATION	Ash Tree Court	DAMAGE	Good Condition	0
FLOOR	Communal Ground Floor	SURFACE TREATMENT	Unsealed 1	2
LOCATION	Wc & Small Boiler Room	ASBESTOS TYPE	Chrysotile (White)	1
TYPE OF SURVEY	Reinspection		RISK SCORE TOTAL	4
DATE OF SURVEY	14th Jan 2026	IDENTIFICATION LEVEL	Inspected	
SURVEYOR	Jamie Cain	ACCESSIBILITY	Low	
NEXT INSPECTION	14th Jan 2027	MATERIAL HAZARD RATING	V.LOW	PRIORITY 3 Manage
