Legionella Bacteria Risk Assessment

Client: Arches Housing

Premises: Ashtree Court
Eccles Street
Sheffield
South Yorkshire
S9 1LR

Date: 03.04.2017

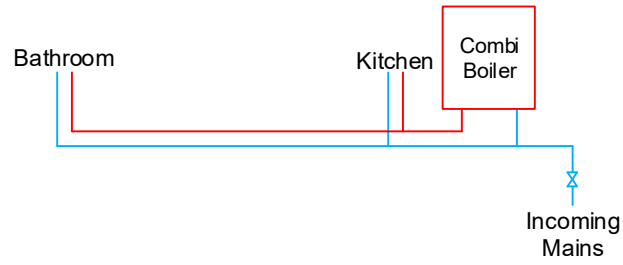
Typical Flat (Flat 2)

Legionella Risk Assessment and Legionella Control Specialists	
Property: Arches Housing, Ashtree Court Date: 03.04.2017 Drawn by: M. Glossop	
Mains cold water	 
Hot water flow	 
Isolation Valve
